FILAMENT COMPOSITE MATERIAL LANDING
GEAR PROGRAM, VOLUME I

Bendix Corporation

Air Force Flight Dynamics Laboratory

AFFDL TR 72-78, Vol. I

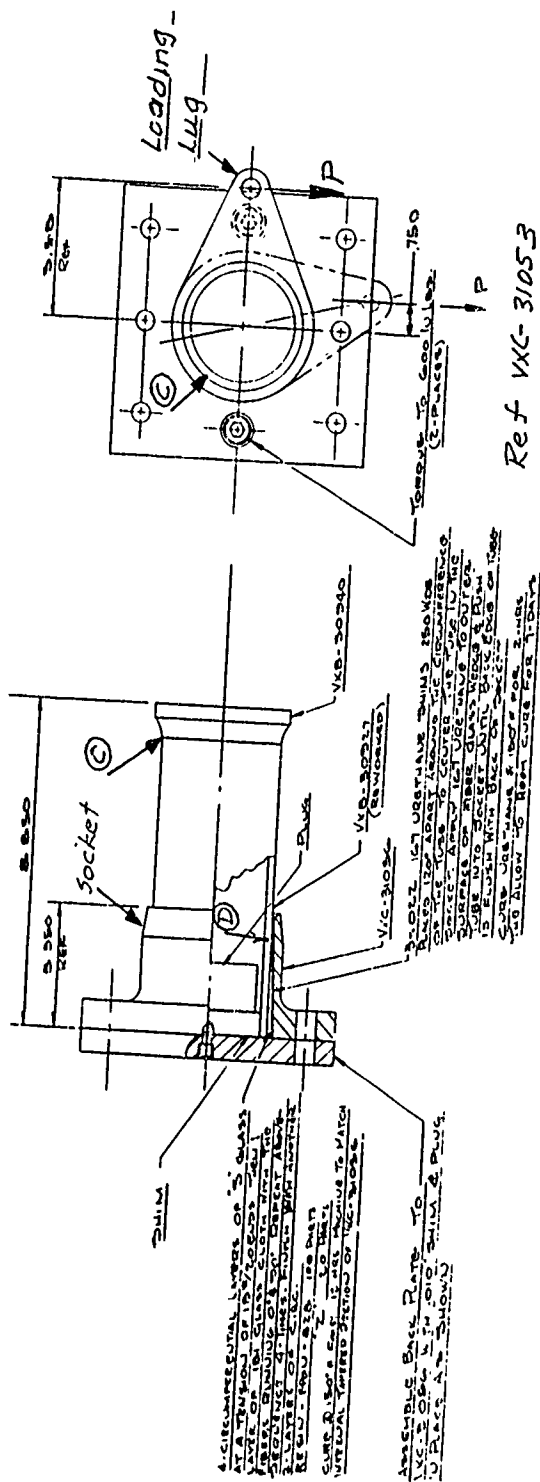
Figure 5-73. Boron-Epoxy Cylinder Specimen, Forty-Eight-Ply (Third Design)

It was apparent that further information regarding the strength of this type of socket joint could be obtained by cropping off the end of the failed tube and building up a second joint using the original steel fittings. For this purpose the design of Figures 5-73 and 5-74 were evolved.

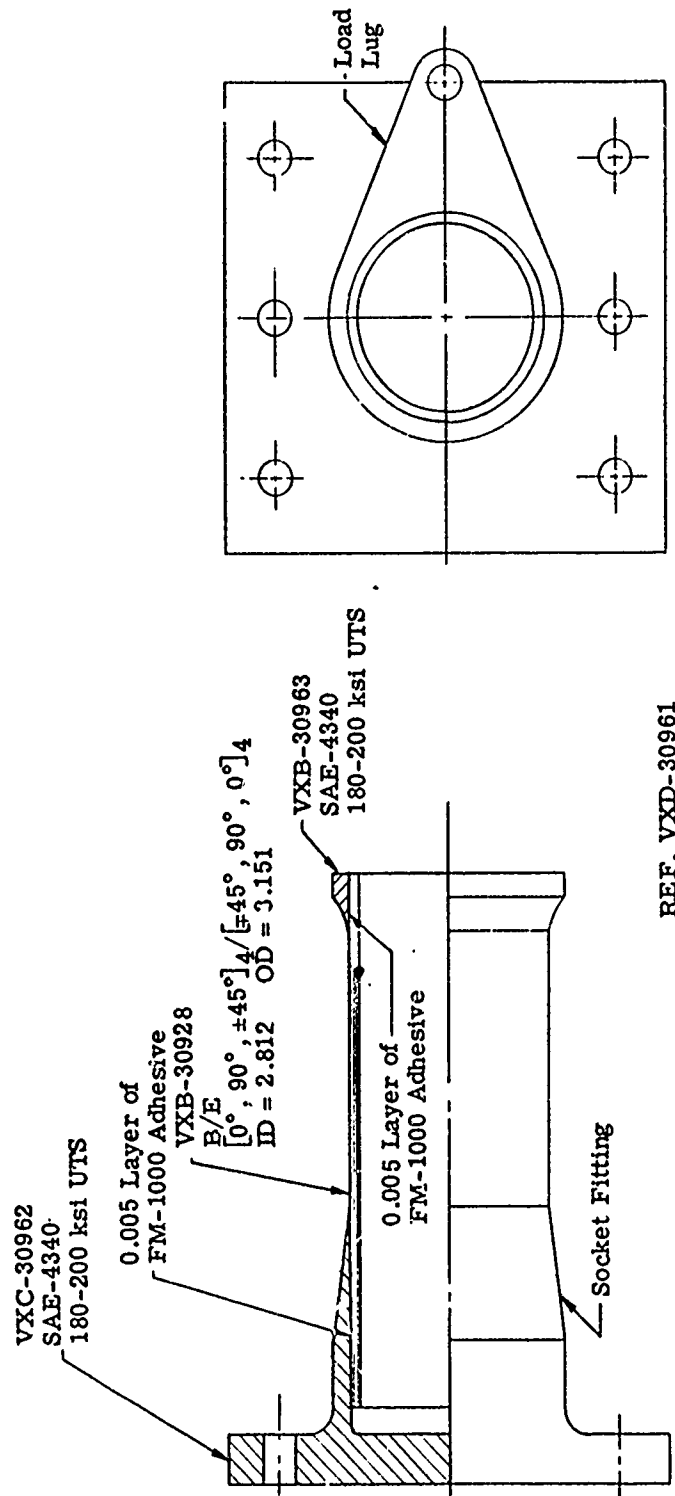
Figure 5-77. Cylinder Specimen, Boron-Epoxy, Thirty-Two-Ply (First Design)

The specimen as originally designed is depicted in Figure 5-77. This specimen was meant to simulate the loading and ply pattern associated with the lower end of the outer cylinder design shown in Figure 5-56. For the reasons discussed at the beginning of this paragraph, this ply pattern was discarded for use in the outer cylinder. However, this cylinder specimen had already been fabricated when this decision was made. It was decided to test the specimen anyway since useful design information applicable to the finally adopted outer cylinder design could still be obtained. However, based on the experience derived from testing the forty-eight-ply specimen, it was decided to discard the bonded type socket joint shown in Figure 5-77.

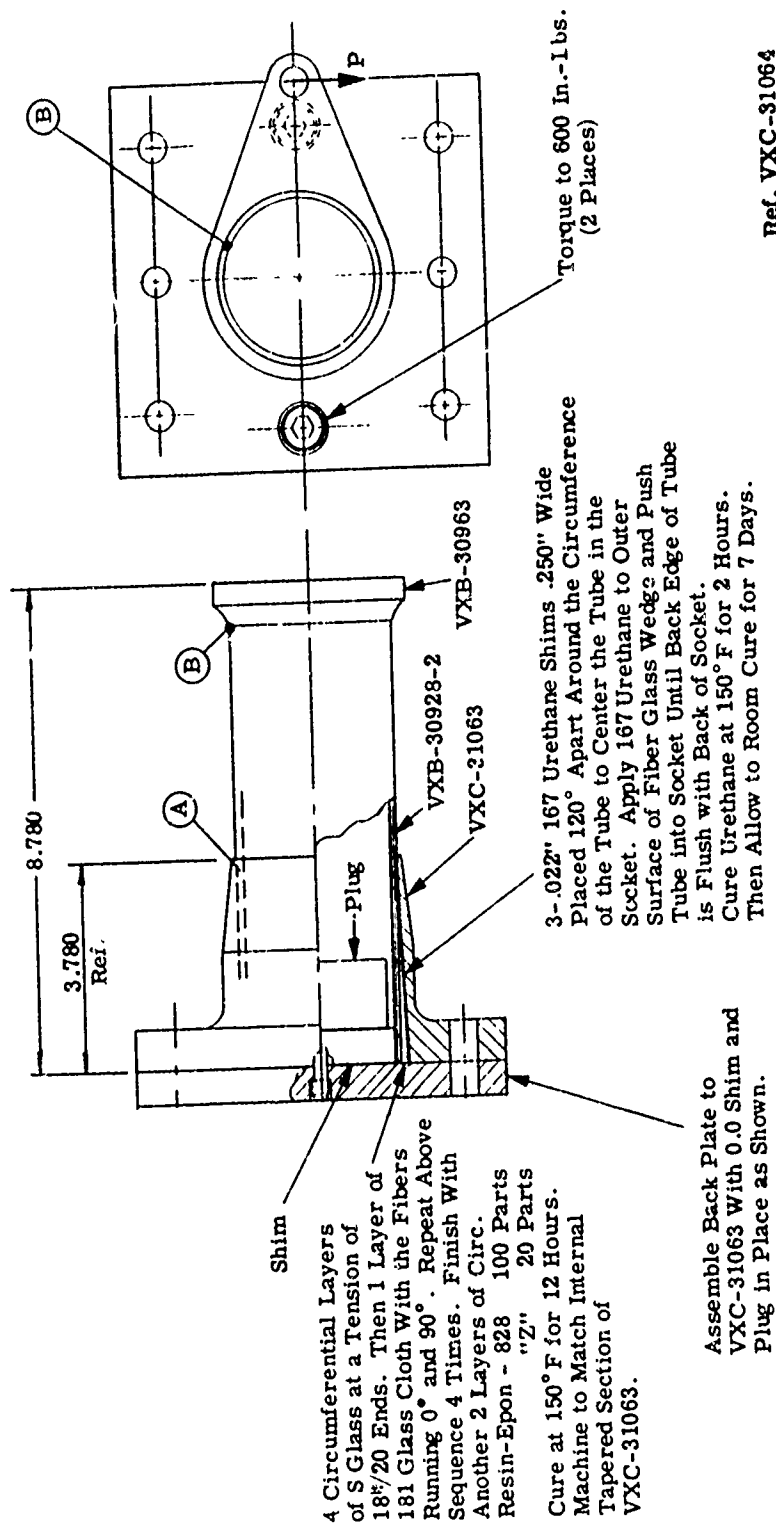
Figure 5-78. Cylinder Specimen, Boron-Epoxy Thirty-Two-Ply (Second Design)

The design selected for the thirty-two-ply cylinder is shown in Figure 5-78 which incorporates the socket type joint finally adopted for the prototype outer cylinder-trunnion joint, Figure 5-80. The stress analysis indicated the cylinder to have a strength $P = 15000$ pounds with failure to occur at Point A and the loading lug to have a strength $P = 13000$ pounds with failure to be in shear along the joint periphery at Point B. The stress calculations are given in Appendix E-1, Item 3.

During the test the specimen failed by rupture of the cylinder in the region around Point A, Figures 5-78 and 5-79, at 13000 pounds. Therefore the cylinder sustained a load of 13/15 or 0.87 of the predicted value. This test also indicated that the loading lug joint was capable of supporting a shear stress in excess of 3360 psi.

A C-scan inspection of the composite cylinder indicated some possible regions of delamination within the cylinder wall as fabricated. These lapses in structural integrity might have had some influence on the specimen falling somewhat short of the target load. The details of the C-scan inspection are given in Figure 8-60.

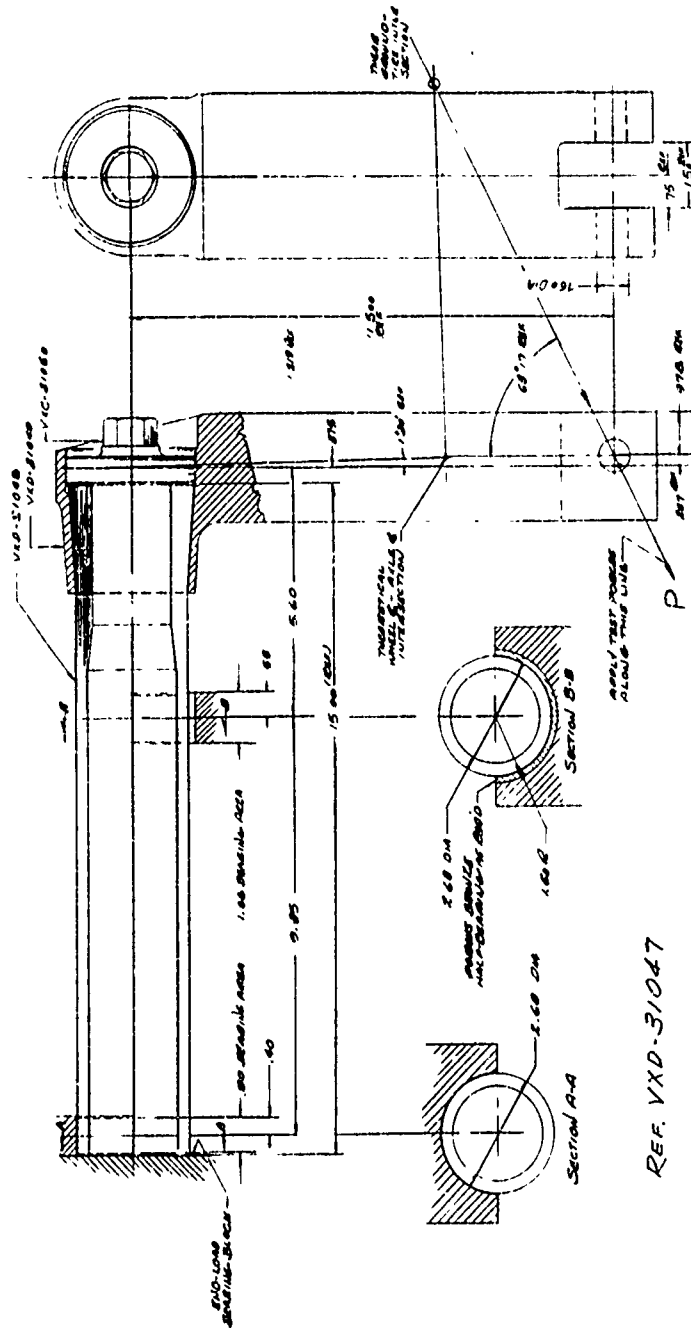
Figure 5-95. Boron-Epoxy Piston Specimen

A strength analysis indicated a rupture load capability for the setup of Figure 5-95 to be $P = 14000$ pounds. During test the load was increased in increments in the attempt to reach this load level. The specimen sustained a rupture at 9300 pounds or 67 percent of the target ultimate load. The rupture occurred at the edge of the 1.06-inch bearing pad, Figure 5-98.

The test fell somewhat short of the target load. However, the results were clouded by the rather severe delamination which existed in the composite cylinder. Nevertheless, the test was considered a success, since it provided an opportunity for Hercules to perform a fabrication trial from which techniques were derived aimed at producing on the next effort a cylinder of substantially improved quality. In addition since the specimen did successfully support a load of significant magnitude, the test results tend to confirm the structural integrity of the Bendix socket joint design.

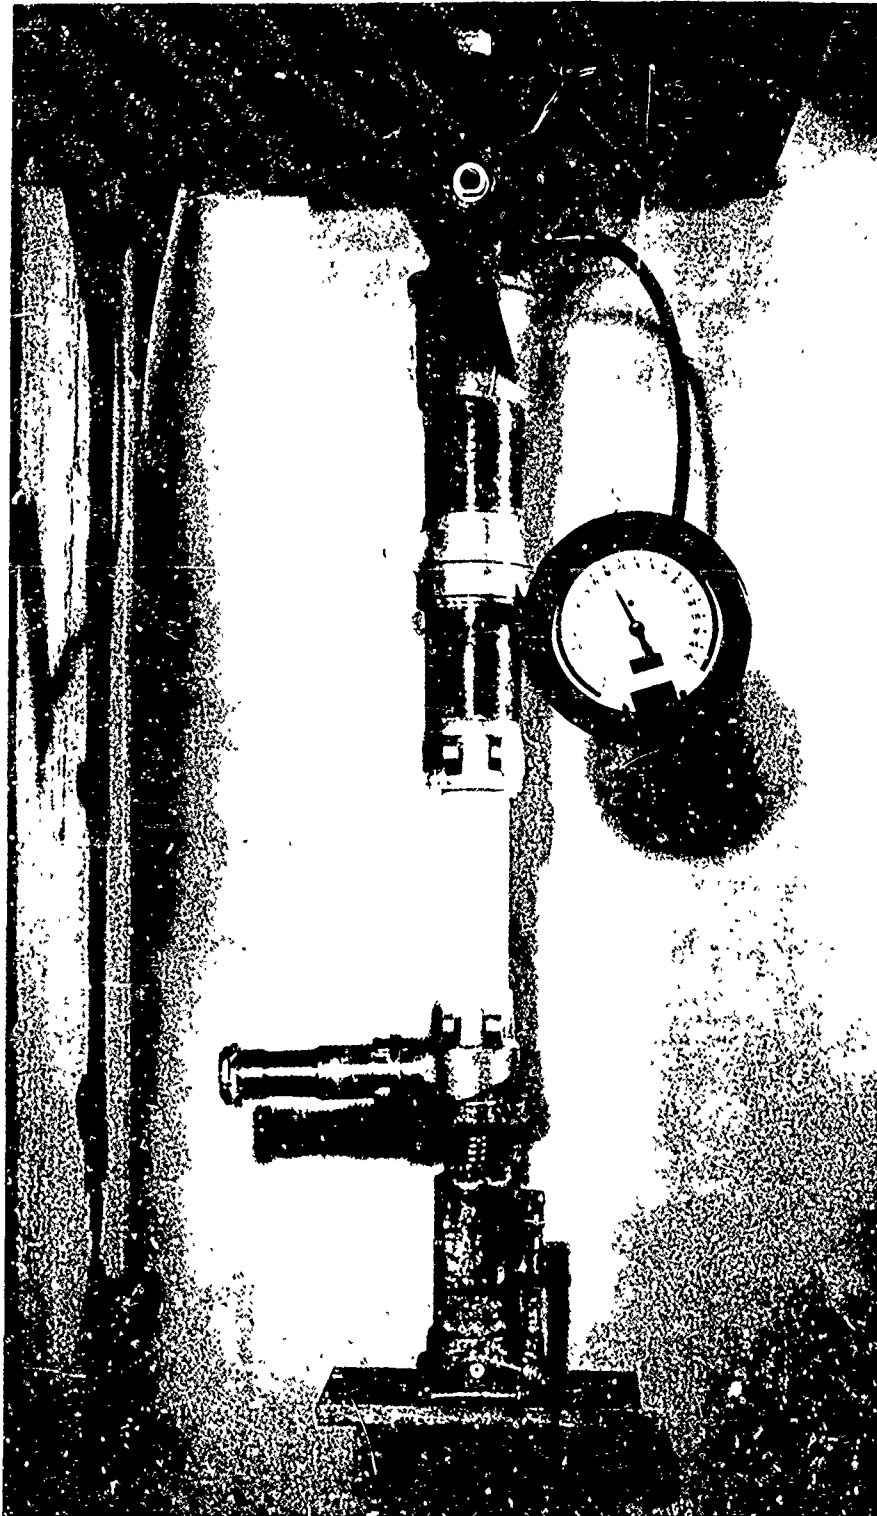
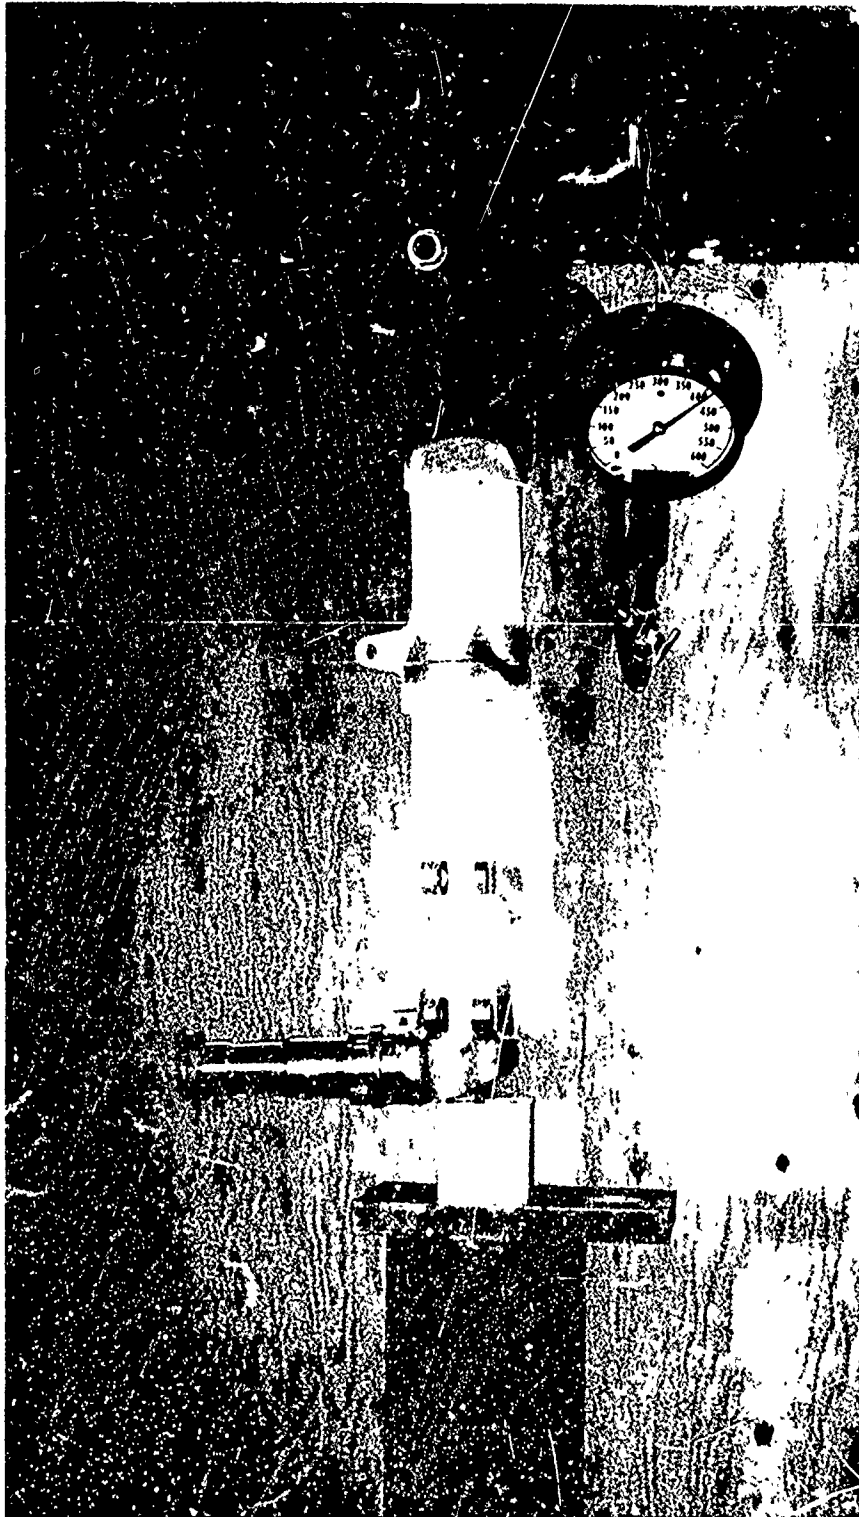
Results - No perceptible leakage or loss of pressure occurred during this test.

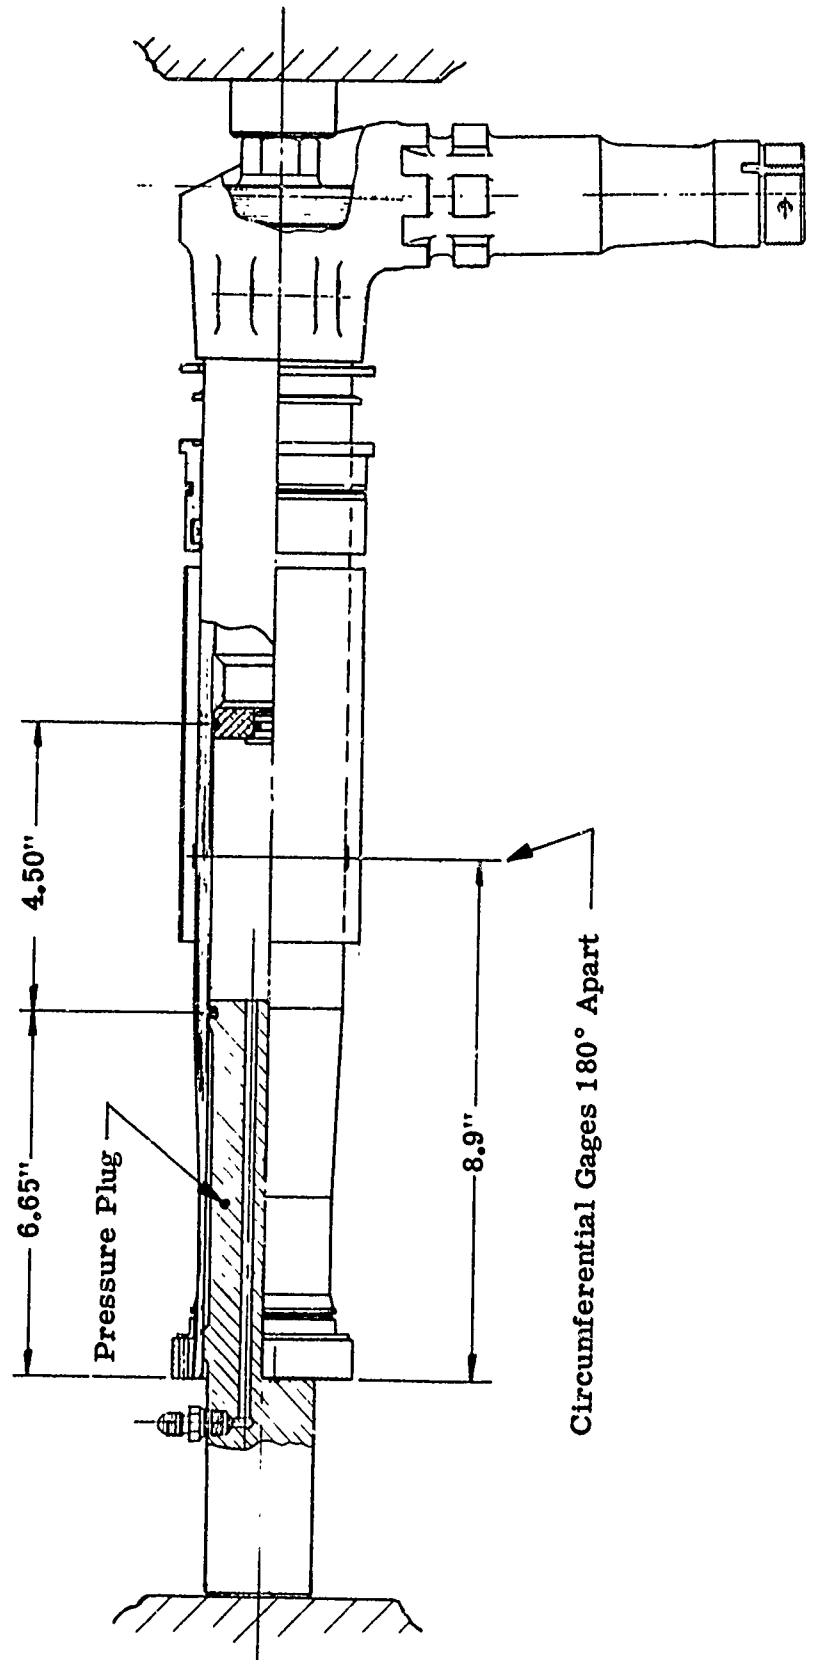
Figure 7-4. Proof Pressure Test

Results - There were no signs of yielding, leakage, or permanent deformation after any of the three tests. The OD of the piston measured 2.676 inches before testing and there was no change after completion of testing.

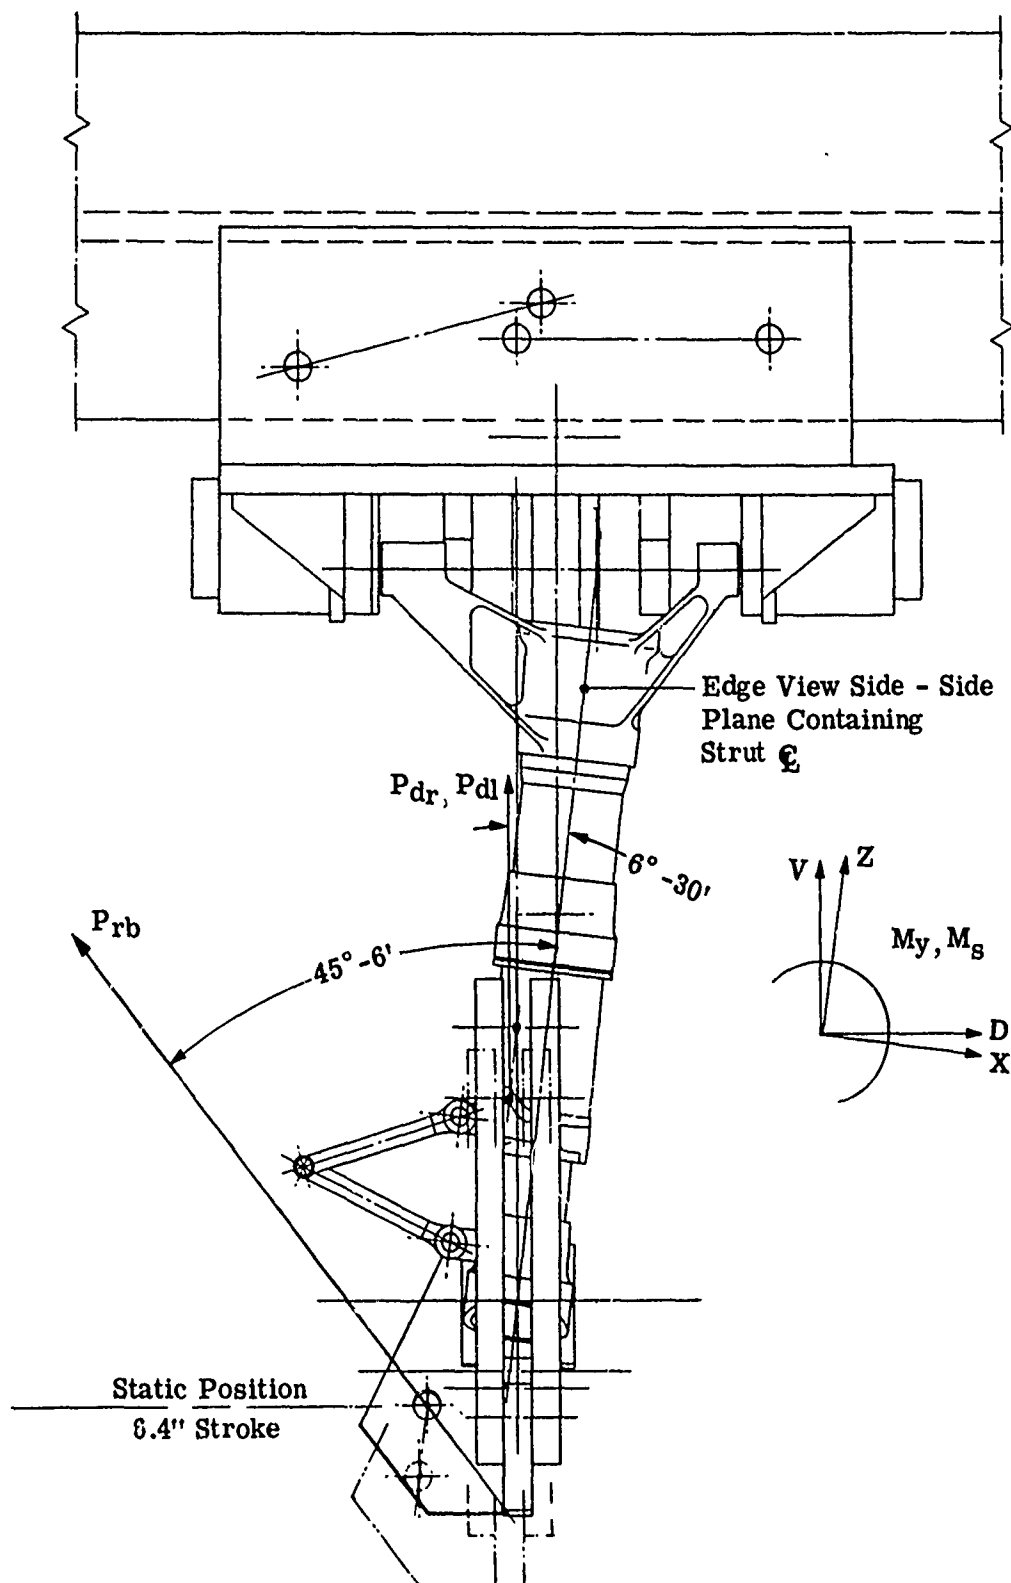
Figure 7-8. Gear Assembly in Static Loading Rig

The shock absorber assembly was installed in a loading fixture incorporating a support geometry identical to that in the aircraft, Figures 7-8 and 7-9. Ground loads were applied through an axle fixture simulating the wheel and brake action, Figures 7-10 and 7-11. The loads were applied by hydraulic jack along lines passing through the theoretical ground contact point. The load direction coincided with the load resultant of the X_A , Y_A and Z_A components from Table 4-1.

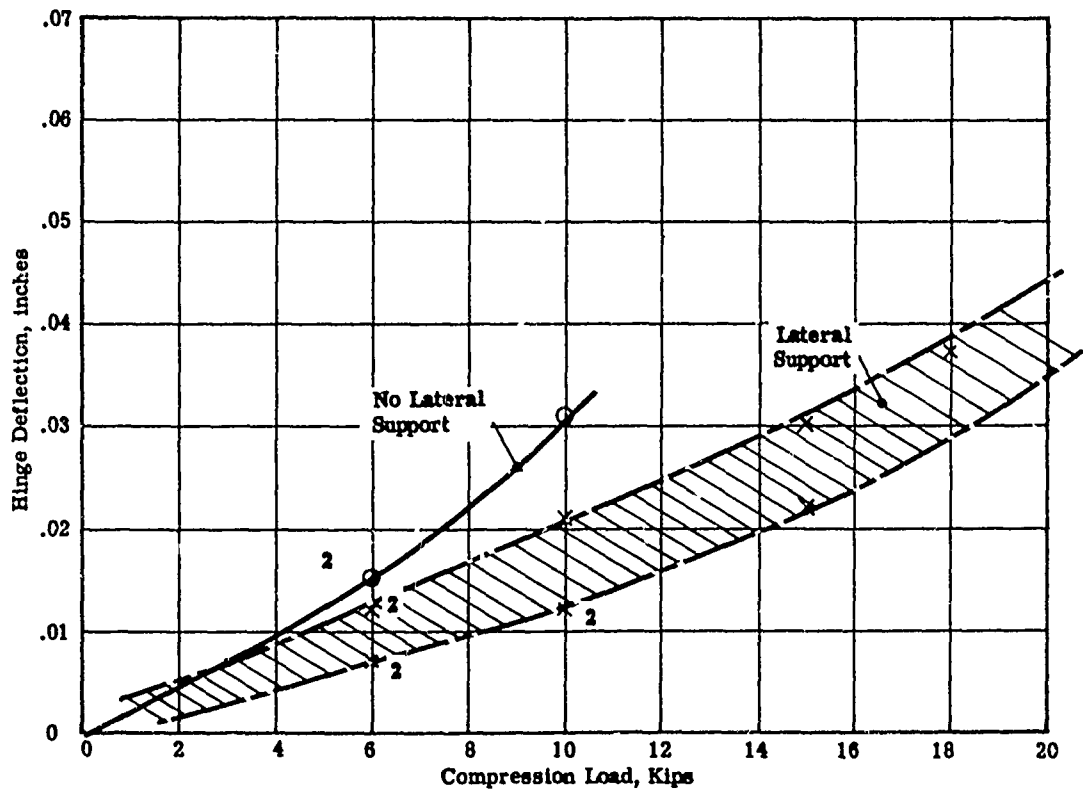
Figure 7-33. Side Brace Hinge Deflections

Hinge pin deflections were measured for loadings 4 and 5. These deflections are shown plotted against load in Figure 7-33, curve labelled "no lateral support."

Prior to the application of further compression loadings, an analysis was made of the lateral hinge pin deflections measured during loadings 4 and 5. The deflections plot, Figure 7-33, indicated that with the brace supported as a simple pin ended column, excessive deflections would be experienced at the higher loads, which would lead to premature collapse. It was therefore decided to install the lateral support illustrated in Figure 7-29. This support simulates the aircraft installation which includes a landing gear extension downlock mechanism which attaches to the side brace at this location.

Compression loadings 8 through 9, Table 7-3, produced the hinge pin deflections plotted in Figure 7-33 and labelled "lateral support." It is apparent that considerably less lateral deflection was experienced with the lateral support installed.

A compression load level of 98 percent design limit was reached when failure of both upper links was experienced at a location just above the hinge pin, Figure 7-30. Failure was due to rupture of all four boron-epoxy flanges. Failure was attributed to excessive deflections of the hinge pin which caused the axial loading to shift toward the inner edges of the flanges.

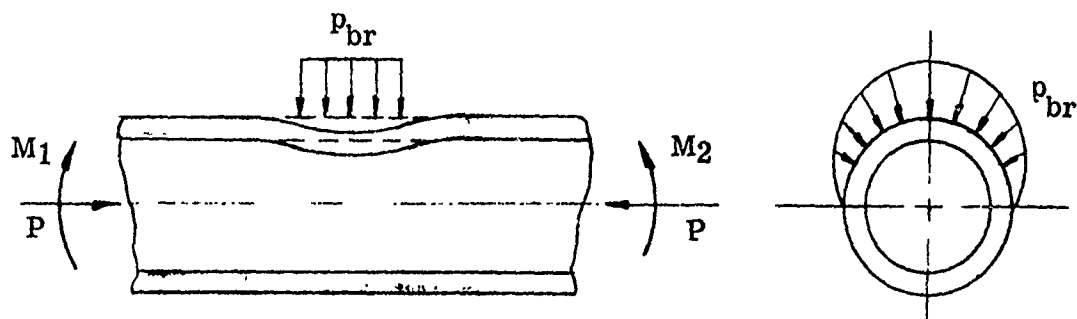
However, further consideration must be given to the possibility that the stresses are more critical on the compression side, particularly with respect to the contribution from the localized bearing load. This situation is illustrated by the simplified model below.

There is the prospect that the compression stresses due to local wall bending produced by the bearing pressure p_{br} when combined with the compression stresses due to the nominal loads M and P may result in a more critical situation compared to material strength than on the tension side. Consideration of localized effects of this type is more important with composite construction than with the more ductile conventional materials. Further detailed analysis of this particular loading configuration appears warranted.
